RE: Site Inspection, Mining Exploration and Development, Roberts Bottom Project,
S/019/036 (UTU-69849), Grand County, Utah

Date of Inspection: March 20, 2001
Time of Inspection: 1600 - 1625
Conditions: Partly cloudy
Participants: Wayne Hedberg, Tony Gallegos, DOGM

Purpose of Inspection: To examine the condition of this site listed as possibly abandoned

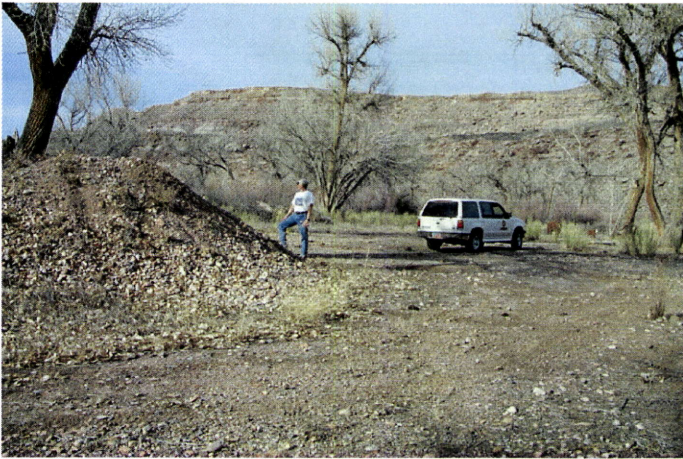
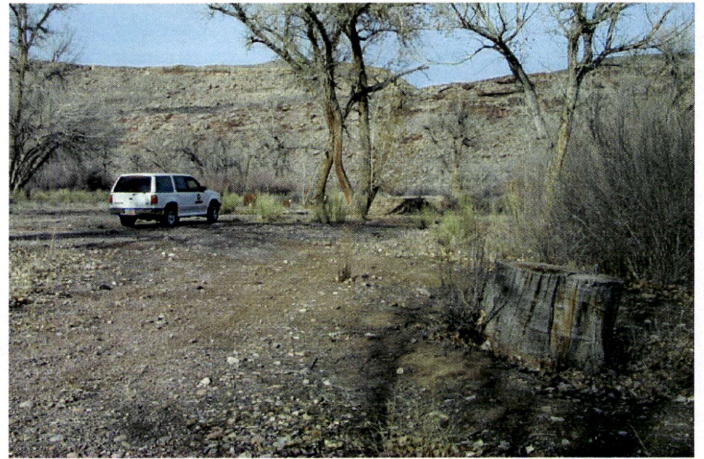
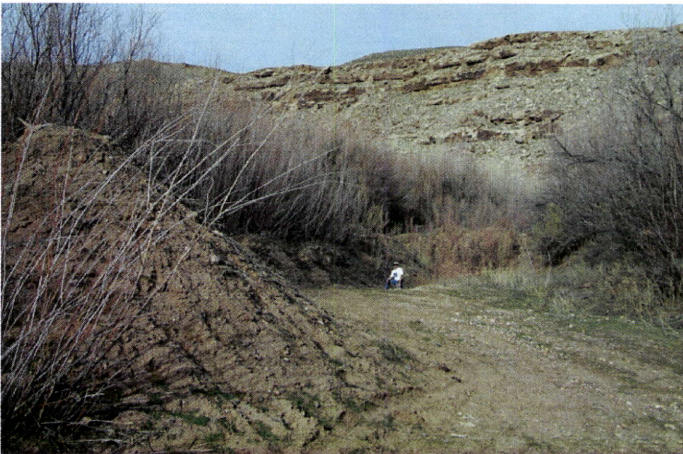
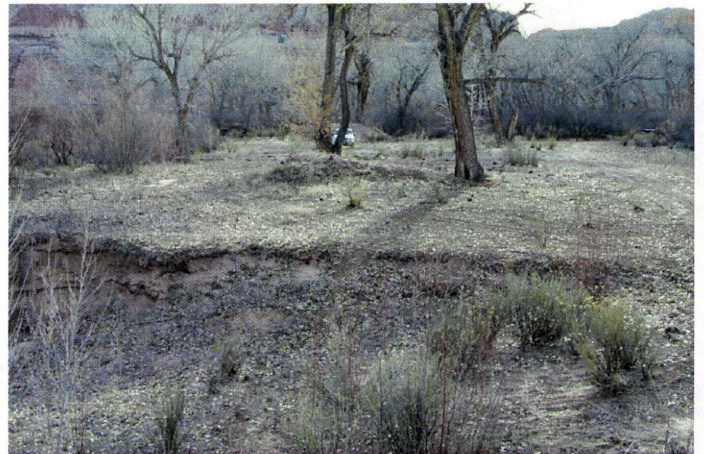
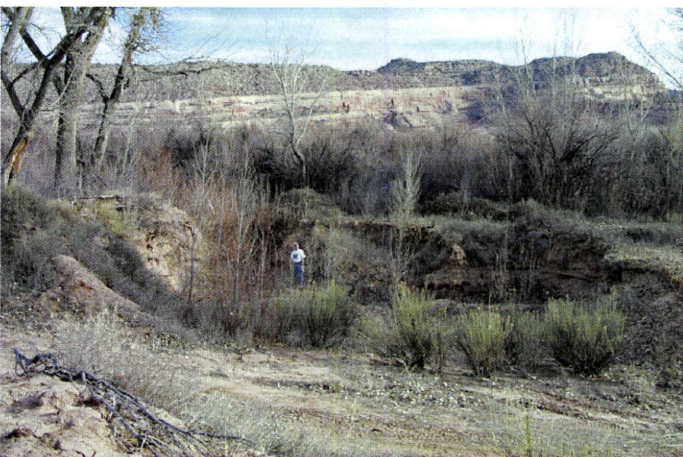
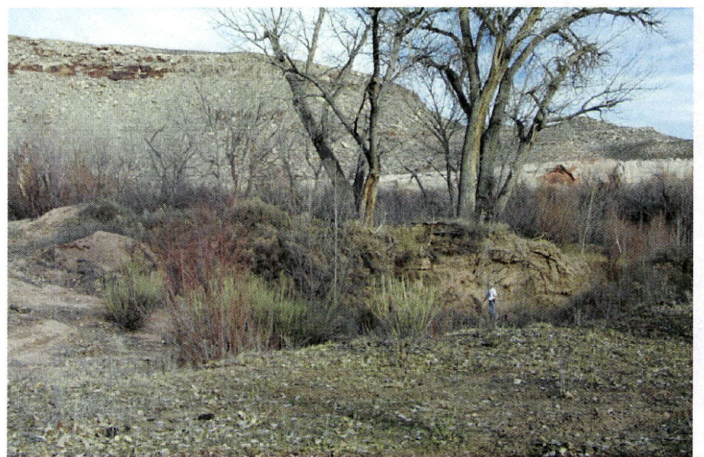
S/019/036
ROBERTS POTOM
3/20/01

There was no equipment or vehicle present at the mine site at the time of this inspection. There were a large number of cows and calves grazing in the area. Features at the main portion of the site include a gravel pile in the flat area where the cottonwood trees are located, and a large metal pipe serving as a gatepost when the operation was active. Photographs were taken to document the features present in this portion of the site.

Roads into the site showed signs of recent use by motorcycles and 4-wheeled ATV's. From the main area, we walked down the road leading to the riverbank. Down by the Dolores River there is a trench excavation with a nearby pile of soils from the excavation. Photographs were taken showing the size and depth of the trench. The area appears to mainly be used now as a camping area with camp sites down by the river and also back in the Cottonwood trees.

Back in the main area there is also an earthen ramp probably used for off-loading equipment. Railroad ties and metal fence posts are used to contain the earthen fill. There is an excavation in the northern end of this area with a number of earthen piles nearby. The excavation is slumped in on the edges and some natural invasion of vegetation has occurred. The piles near this excavation show signs of frequent ORV use.

In conclusion, there are some minor disturbances remaining at the site that should have been reclaimed; however, there are no significant safety or environmental hazards present. The Division will need to take the next steps to close out the small mine notice for this abandoned site.
